Test Report No : 231204136-02

CABLE TRAY SAMPLE , 150x50x2mm Perforated Tray, Pre-Galvanised

Test Report

Sample ID : 231204136
 Test Method : ASTM B 117:2019
 Test Duration : 96 hours
 Temperature : 35°C ± 2°C
 Start Date : 05-12-2023

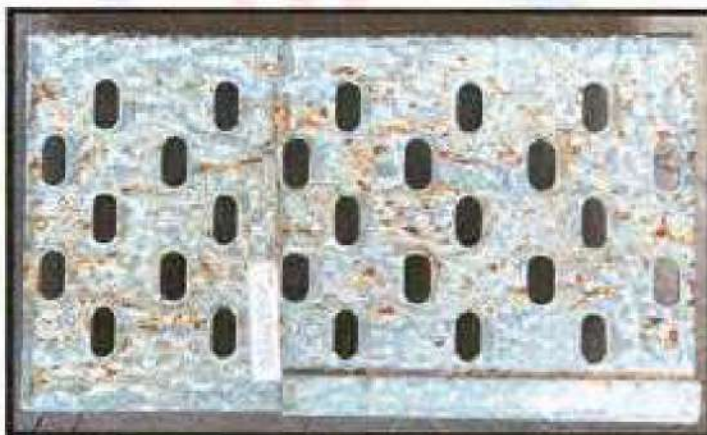
Photographic evidence after exposure period -

| S.No. | Time Interval | Observations |
|---|---|---|
| 3. | After 72 hours | Slight red rust was observed only on some areas on the surface of the sample. |
| 4. | After 96 hours | Red rust was observed only on some areas on the surface of the sample. |
