# Siddhartha Spectro Pvt. Ltd.

Test Report No : 231204139-02

CABLE TRAY SAMPLE , 300x150x2mm Ladder Tray,  
Hot Dip Galvanised

Sample ID : 231204139  
 Test Method : ASTM B 117:2019  
 Test Duration : 96 hours  
 Temperature : 35°C ± 2°C  
 Start Date : 05-12-2023

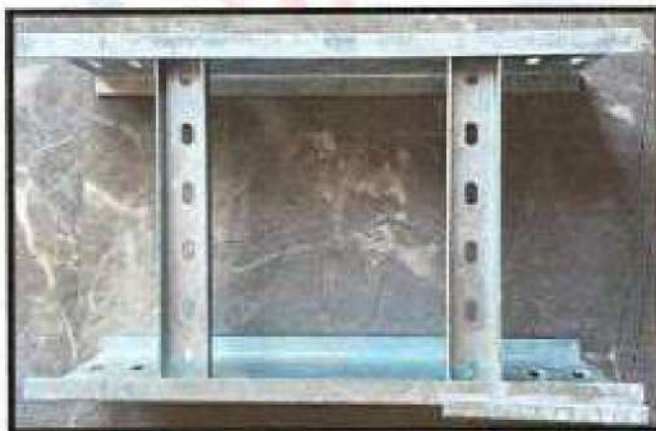
Photographic evidence after exposure period -

S.No.	Time Interval	Observations
1.	After 24 hours	No signs of corrosion were observed on the surface of the sample.
2.	After 48 hours	No signs of corrosion were observed on the surface of the sample.
3.	After 72 hours	No signs of corrosion were observed on the surface of the sample.
4.	After 96 hours	No signs of corrosion were observed on the surface of the sample.
